San Acacia River Mile 111 Priority Site

**Bend Migration Assessment
Final Report**

March 2005

Tamara M. Massong

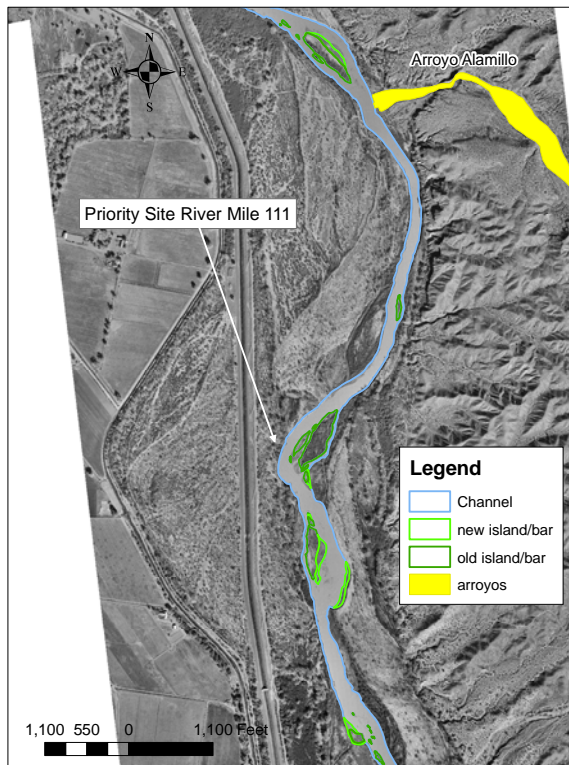
South of the San Acacia diversion dam (5.2 miles), the Rio Grande channel is migrating southwest, which is causing rapid erosion of the west channel bank. The migration is nearing the levee (Figure 1) and has created the potential to jeopardize levee integrity. This site is listed by the Bureau of Reclamation-Albuquerque Area Office as a River Maintenance Priority Site: San Acacia Priority Site at RM 111 (RM 111). The rate and direction of bend migration is evaluated in this analysis to address river maintenance needs at the RM 111 Priority Site: Reclamation is pursuing a levee setback project at this location. This bend evaluation is intended to assist in estimating the project life for the levee setback. The assessment is based primarily on comparing river locations on current and historical aerial photographs with a Geographic Information System (ArcMap 8.2).

Figure 1: Recent aerial photograph (2001) of the priority site at RM 111.

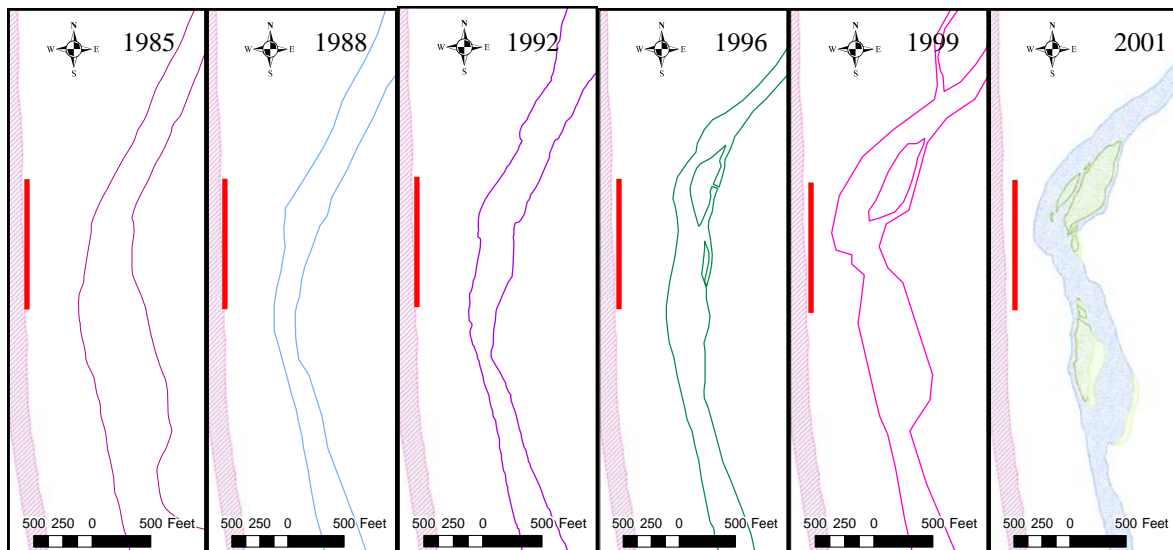
The evolution of the bend at RM 111 is divided into two phases: 1-bend initiation and pattern development (1985-1996) and 2-initiation of lateral migration (1996-present). The RM 111 bend first appeared in the 1985 digitized data as a slight undulation in the bankline (Figure 2). The bend became slightly more distinct in the 1988 photos but its apex had not migrated significantly. By 1992, the bend was still a small and shallow undulation in the bankline, but it had developed a rounded curvature. Another small bend formed 1988-1992, immediately upstream of the RM 111 bend. Although these two bends were still distinct undulations in the 1996 bankline, they became somewhat connected as the entire bankline began to migrate westward. The apex of this new, large bend was slightly upstream and westward of the original RM 111 bend found in 1992. Along with this bend evolution, a medial bar had developed in the right-center of the 1996 active channel. The development of the island indicates a significant shifting of the thalweg both in location and likely an increase in depth. The change in thalweg characteristics are consistent with the braided-to-meandering transition/evolution that has been documented upstream in this reach of the Rio Grande (Reclamation 2003) and farther upstream near Albuquerque, NM (Massong 2004). The transitioned channels usually have a relatively deep thalweg which easily erodes bank material and laterally migrate.

Figure 2: River channel and bank outlines at RM 111 from 1985 (left) to 2001 (right) displaying the development of the RM 111 bend (upstream bend) and the bend that has developed immediately downstream of the project area. The pink striped polygon on the west side of each inset figure is the current levee location. The red line identifies the present location of potential levee erosion.

Between 1996-1999, the bend began to migrate laterally (Figure 2), rounding its bankline and completely engulfing the two smaller bends found in the 1996 photos. In conjunction with migration of the west bank, the medial bar immediately upstream grew westward. The older sections of this bar became vegetated and now appear stable (cover photo); significant vegetation growth occurred 1996-1999. No bend migration occurred between 1999 and 2001; however, the downstream end of the bend appears to have been eroded. The lack of bend migration in this time frame is likely due to relatively lower spring flows in the 1999-2001 period (Appendix A, Reclamation 2003). Although no migration occurred 1999-2001, the medial bar continued to grow creating a smaller wetted channel width. This decrease in channel width enhanced the single thalweg that was already present: the thalweg appeared to become more prominent along the west bank and likely deepened. Although these recent changes appear minor, they appear to be preparing the bend to continue the migration trend once larger flows return.

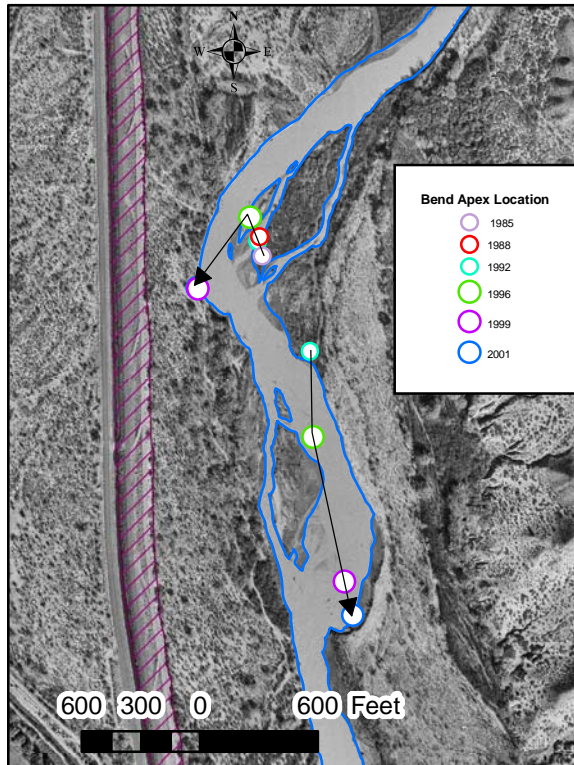
The migration characteristics of two meander bends were assessed: 1-the priority site bend, RM 111 (Figure 3); and the bend immediately downstream (Appendix B). As discussed earlier, the bend located at RM 111 initially migrated upstream while it was forming, but then moved rapidly downstream and towards the west levee after it had established its form. Between 1996 and 2001, this bend migrated at an average rate of 90 feet/year (Table 1), with all the migration occurring between 1996 and 1999. Between 1999 and 2001, the migration stalled, however field observations in March 2004 indicate that migration has resumed.

Figure 3: History of apex locations of two bends: bend at RM 111 and the bend immediately downstream. Photo date: 2001.

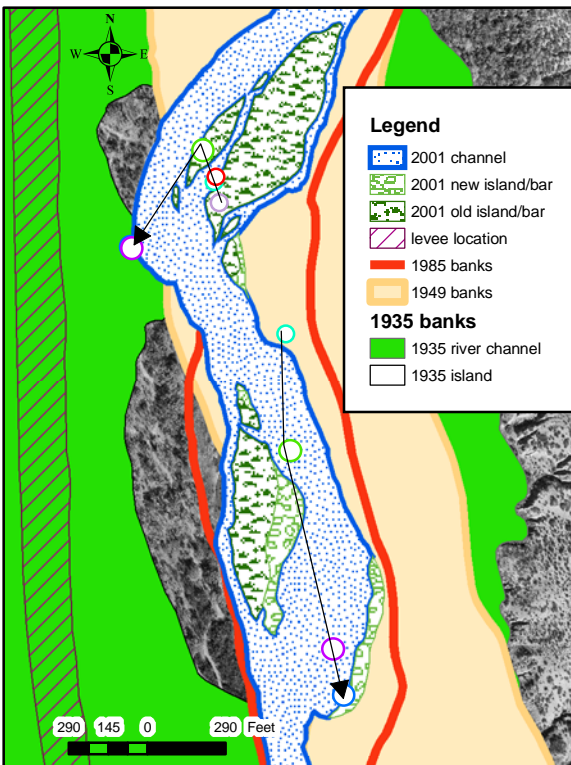
Estimating the exact rate of future migration of the bend at RM 111 is difficult as the bank composition is complex. The bank material at the RM 111 bend contains sediments from a series of historic channels and islands (Figure 4). The oldest bank material at the RM 111 bend is that of the 1918 island (Figure 5) located immediately downstream of the current bend apex; based on field observations, the height of this surface is approximately 10-12 feet above the current channel bed. Between 1918 and 1935, the two 1918 islands became connected and the boundaries were rounded by the river. The eastern edge of the 1935 island was either eroded directly by the river or was mechanically altered as part of the channel re-alignment between 1935 and 1949, either way, the current west bank of the Rio Grande stabilized by 1949 and has shifted little since that time. The island remnants present in the 2001 photos (Figure 4-the uncolored patches left of center in the figure) were those originally mapped in 1918 and hence are likely older than 100 years. The dominant vegetation on these surfaces are mature cottonwoods, grasses, small bushes and the occasional juniper found in the understory. Interestingly, few saltcedar and Russian Olive trees are present. The surface associated with the active 1935 channel is now a terrace with a height of approximately 8 feet (Reclamation 2003).

Figure 4: The current channel location overlain on the historical channels (1935-1949).

The current channel location overlain on the historical channels (1935-1949) show the vegetated island present in 1918 was partially eroded by the Rio Grande in 1949 photos, and that the current channel is actively eroding the northern section of the old island. If the bend continues to migrate in its current direction, it will continue to intersect the old island at the downstream end of the bend. Also, since the current channel can not flank the old island, as the 1935 surface is 8 feet higher than the current channel and can not be flooded, the current channel must completely erode the old island to reach the proposed new levee location.

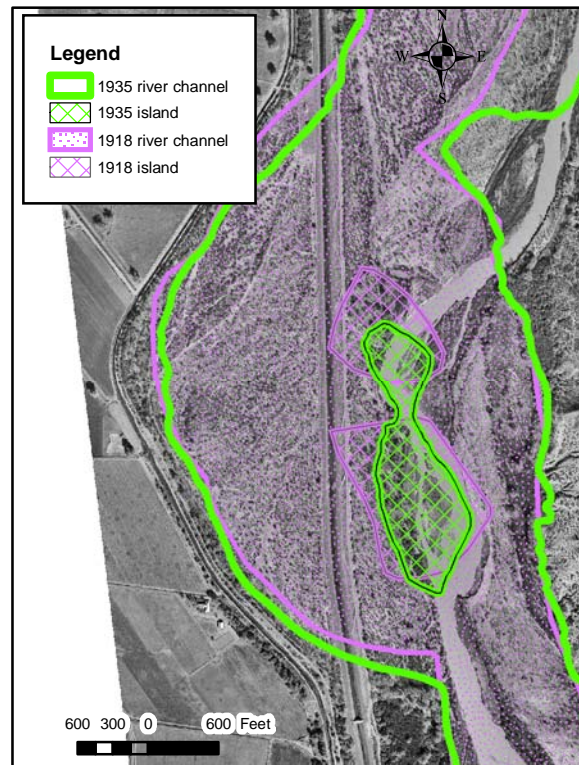
Figure 5: The location of the Rio Grande in 1918 and 1935 at RM 111. Note the large island present in the middle of the bends in 1918 and 1935.

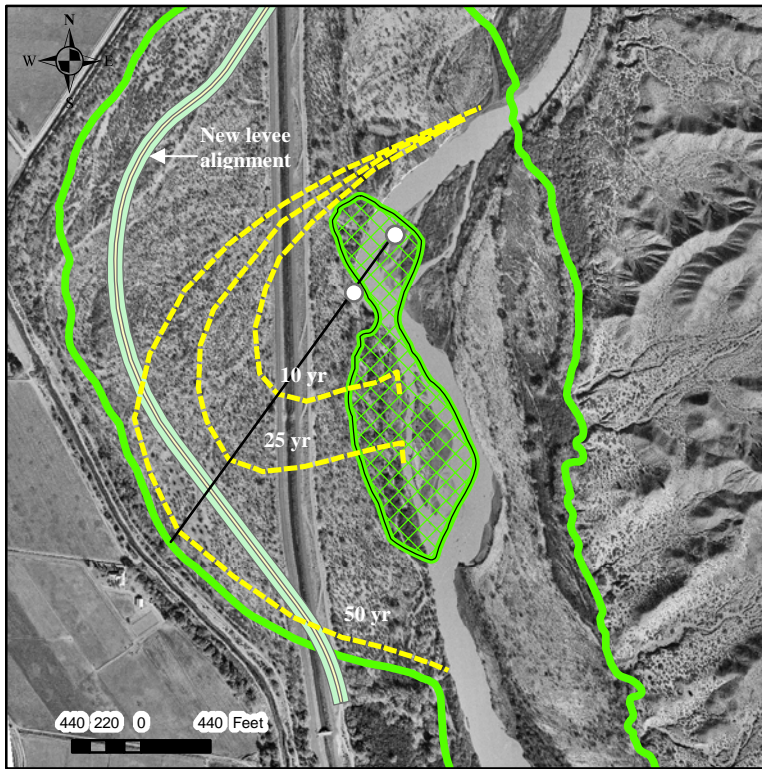
The future migration of the bend at RM 111 was estimated using the current migration direction with a combination of two migration rates at this bend: current migration rate of 90 feet/year for the first 10 years; and the RM 114 migration rate of 40 ft/yr (Smith and Massong 2004) for after the first 10 years. The current migration rate of 90 feet/year was applied for the first 10 years of movement; however, after the first 10 years, the resistant island material is presumed to slow the total migration rates. In the RM 114 assessment, several bends were assessed which had longer migration histories than the RM 111 bend; ~40 feet/year appeared to be representative of migrations of those bends. As those bends are migrating through similar sediments as the 1935 surface at RM 111, they are likely representative of the long term potential at this site. With an average rate of 40 feet/year, the RM 111 bend could reach the 1935 bankline in approximately 50 years (Figure 6). However, the new levee location will be on the inside of the old 1935 bend, thus reducing the bend radius by approximately 450 feet at the estimated bend apex location (Figure 6). As a consequence, the RM 111 bend is projected to reach the new levee alignment in approximately 30 years.

Figure 6: Estimated bend location at Priority Site RM 111 at 10 years, 25 years and 50 years with an overlay of the estimated new levee alignment position. Background photo date is 2001; 1935 channel location in green; 1935 island in green hatch. Estimated new levee alignment provided by Tyler Smith-Reclamation, AAO.

Since the erosion rates of the old 1918 island are unknown, the projected rates of bend migration are relatively poor. Re-assessment of future migration rates at about 15 years should be performed to assess the reasonableness of using the 40 feet/year migration rate. Also, significant peak flows in this reach could also reduce the certainty of these estimates, as large events can rapidly erode sand composed bank material such as those found in the 1935 terrace at RM 111.

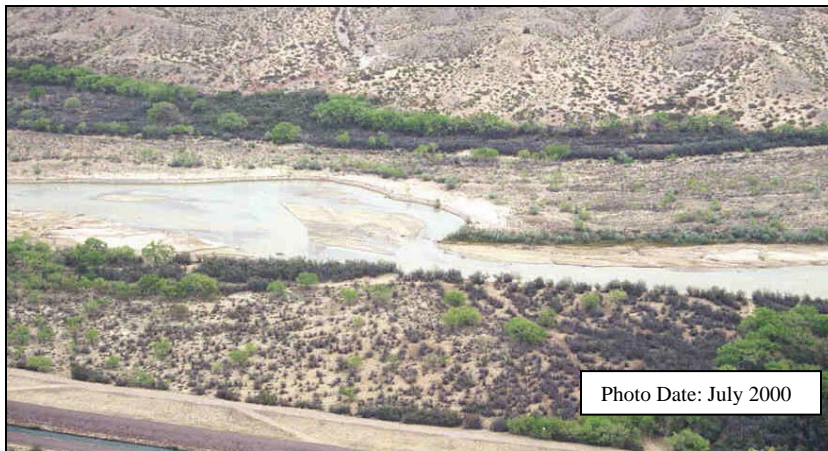
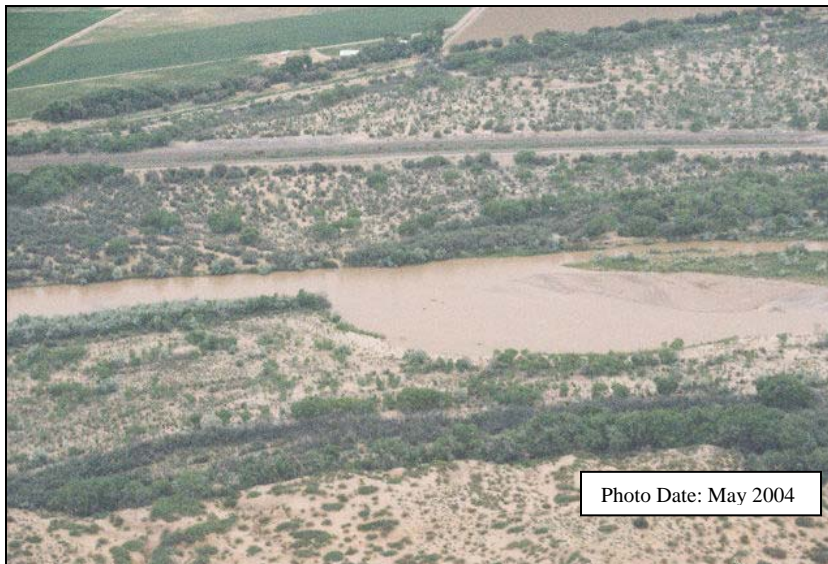
The bend immediately downstream of RM 111 developed between 1992 and 1996 and since that time has migrated and grown (Figure B-1). Between 1996 and 1999, this bend experienced its most rapid migration at 250 feet/year (Figure B-2, Table B-1), before slowing to a rate of 60 feet/year (1999-2001). Similarly to the RM 111 bend, this bend also migrated 2001-2004 based on visual inspections in March 2004 (Figure B-1).

Figure B-1: Photos of the bend immediately downstream from the San Acacia Priority Site RM 111. The top photo (2000) looks toward the east bank. The bottom photo (2004) looks toward the west bank and levee. Notice that the island/bar at the top right of the 2004 photo has fairly new vegetation growth with just the beginnings of woody vegetation (the mint-green vegetation is Russian Olive). The bar is present in the 2000 photo, however not vegetated. Also note that the bend did erode the outside of the bend

between the two photo dates; however the opposing angle makes measurements impossible.

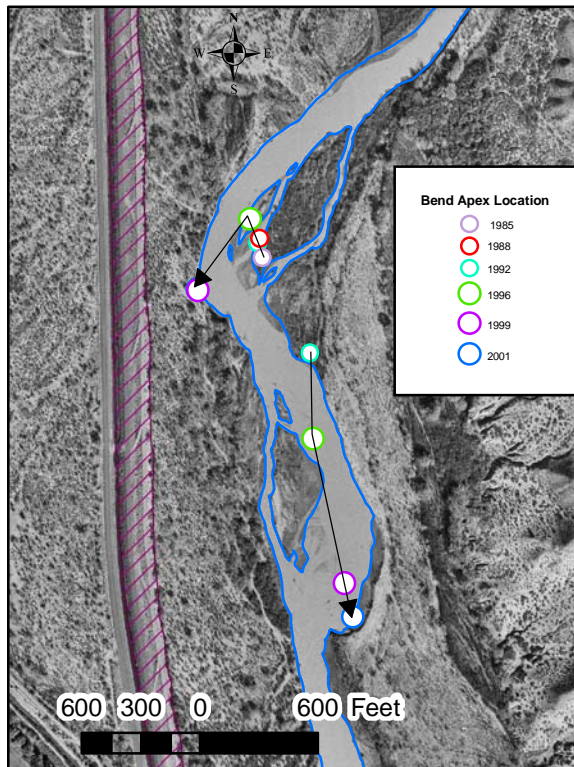
Figure B-2: History of apex locations of two bends: bend at RM 111 and the bend immediately downstream. Photo date: 2001.

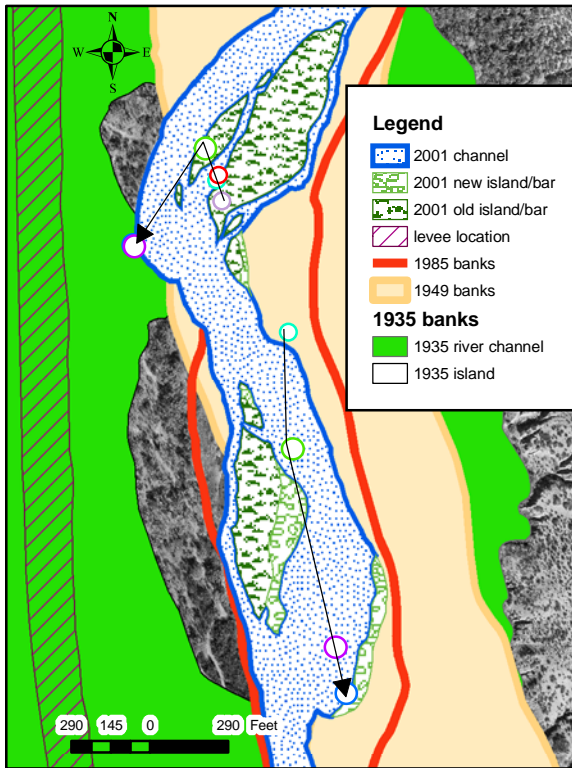
The bank material at the bend downstream of RM 111 is relatively uncomplicated as it is predominantly riverine sediments deposited in the 1980s; the bank height is estimated at 4-6 feet (Reclamation 2003). The Rio Grande had a relatively large channel width in 1985 with a western boundary similar to that present today, while the eastern bank extended well beyond the current location of the channel (Figure B-3). Between 1985 and 1988, the channel re-aligned and narrowed in this section of the reach; as a consequence of this change, the 1988 channel was significantly narrower with most of the eastern portion of the channel abandoned. This section of abandoned channel is now the eastern bankline; it is composed predominantly of loose sand (a.k.a., sugar sand) that is easily eroded by the river. The erosion occurring at this site is mostly parallel to the current active channel, hence the dominant change in the Rio Grande due to this bend migration is active channel widening. Also, the large bend migration rates occurring at this downstream bend are likely higher than would be expected at RM 111 since the

bank material eroding at RM 111 is more cohesive and the bend direction is not parallel to the current active channel. However, the rates of migration at this downstream bend are considered the maximum rates to be expected in this reach of river.

Figure B-3: The current channel location overlain on the historical channels (1935-1949).
